POSTLAUNCH REPORT FOR APOLLO MISSION A-004

(Spacecraft 002)

April 15, 1966

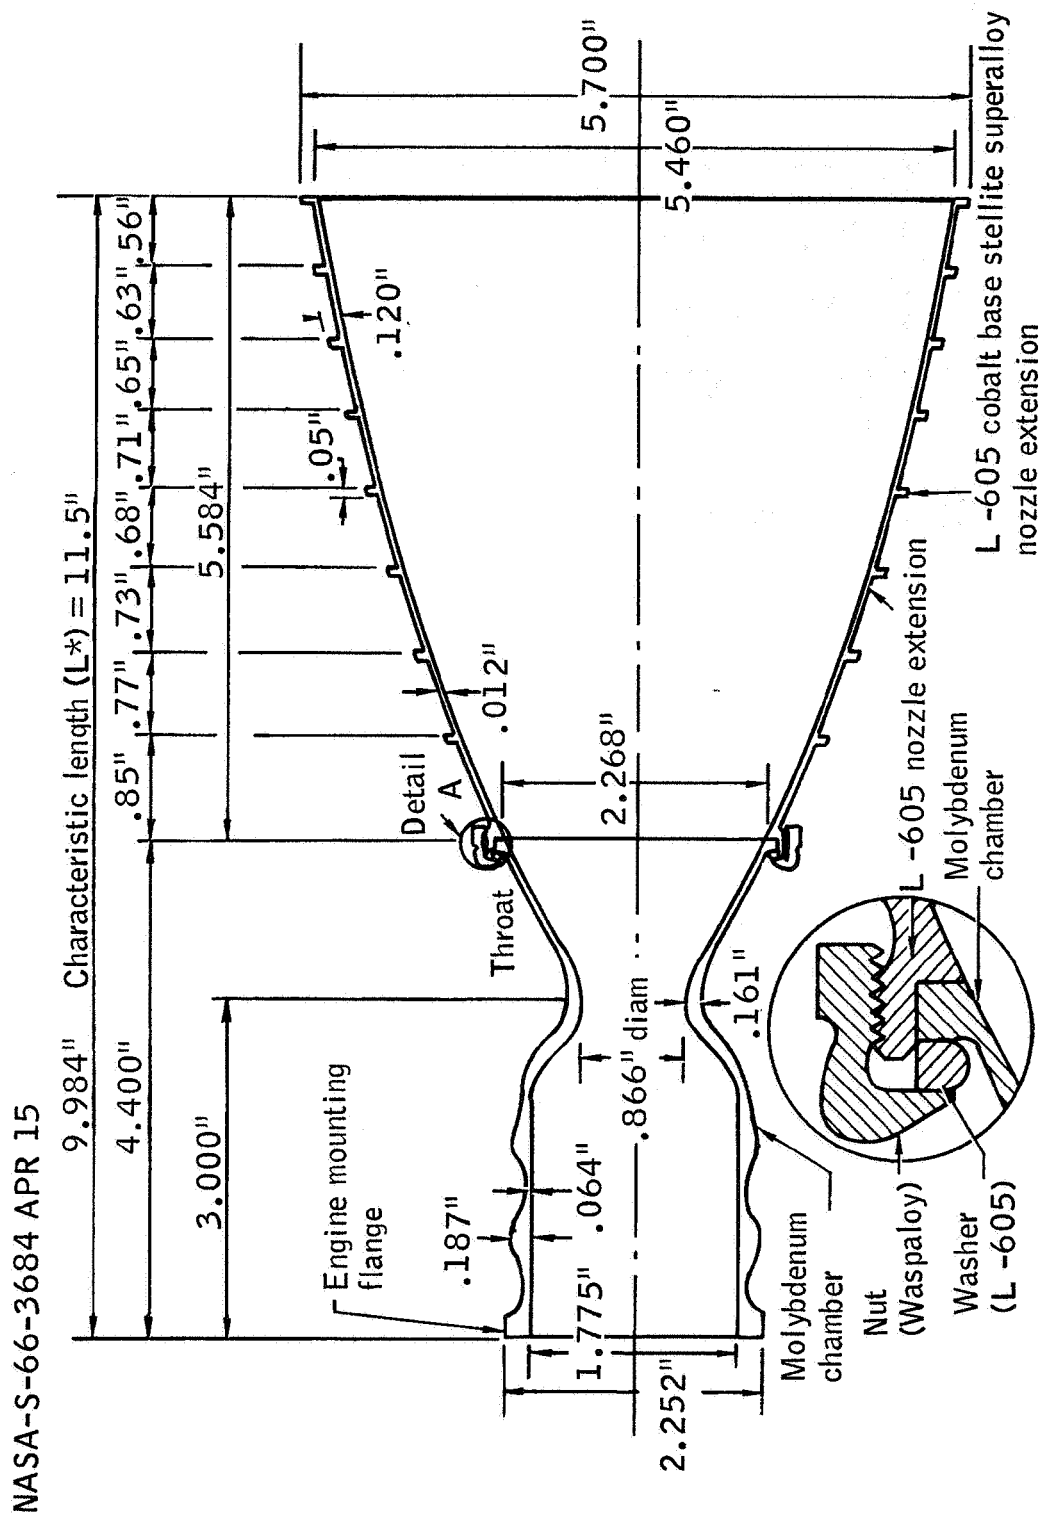
Figure 5.2-4.- Quad D prototype SM RCS engine chamber and nozzle extension, Apollo Mission A-004

Chamber-nozzle extension joint at an expansion area ratio ( $A_c/A_t$ ) of 7.0.

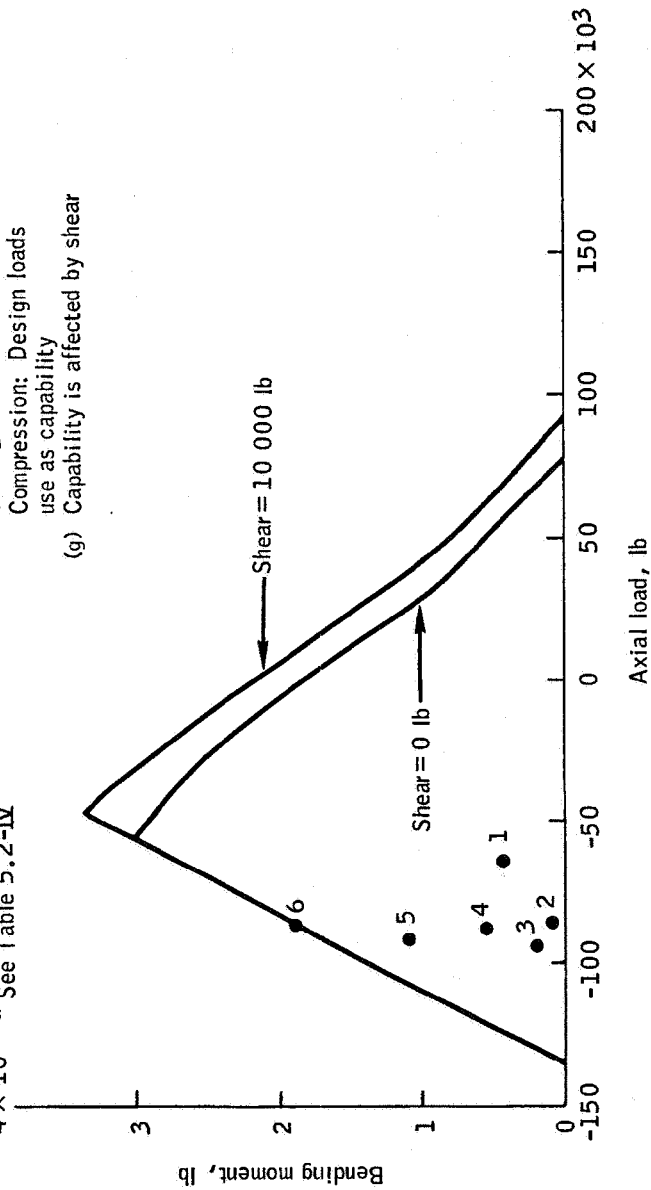
Figure 5.2-9.- CM-SM interface (station X<sub>A</sub>1010) Block I limit design load capabilities envelope and maximum load conditions, Apollo Mission A-004.

- (a) Loads at 312°F
- (b) Pretension 12 000 lb
- (c) Envelope indicates capability of tension tie only
- (d) SM truss or CM pad capability could be less than tension tie
- (e) Failure mode:  
Tension: Rupture of tension tie  
Compression: Unspecified
- (f) Method of determining failure:  
Tension: Analysis (original Block I loads)  
Compression: Design loads use as capability
- (g) Capability is affected by shear

The net body loads at the LES-CM and CM-SM interfaces were calculated using the flight trajectory parameters together with wind-tunnel aerodynamic data. In figure 5.2-9 loads calculated at the CM-SM and SM-adaptor interfaces are compared with the interface limit load capability. A summary of the flight trajectory parameters used to determine these loads is shown in table 5.2-IV. None of the load conditions shown in figure 5.2-9 exceeded the limit load capability of the interfaces. Load condition 6 in figure 5.2-9 was on the limit load design envelope itself because the axial force at the time of abort was approximately twice the planned value. The axial force was high because of the early abort, at which time the launch vehicle thrust was approximately 5 to 6 times as high as for the planned time for the abort. (See table 4.1-I and figs. 6.1-3 and 6.1-4.)

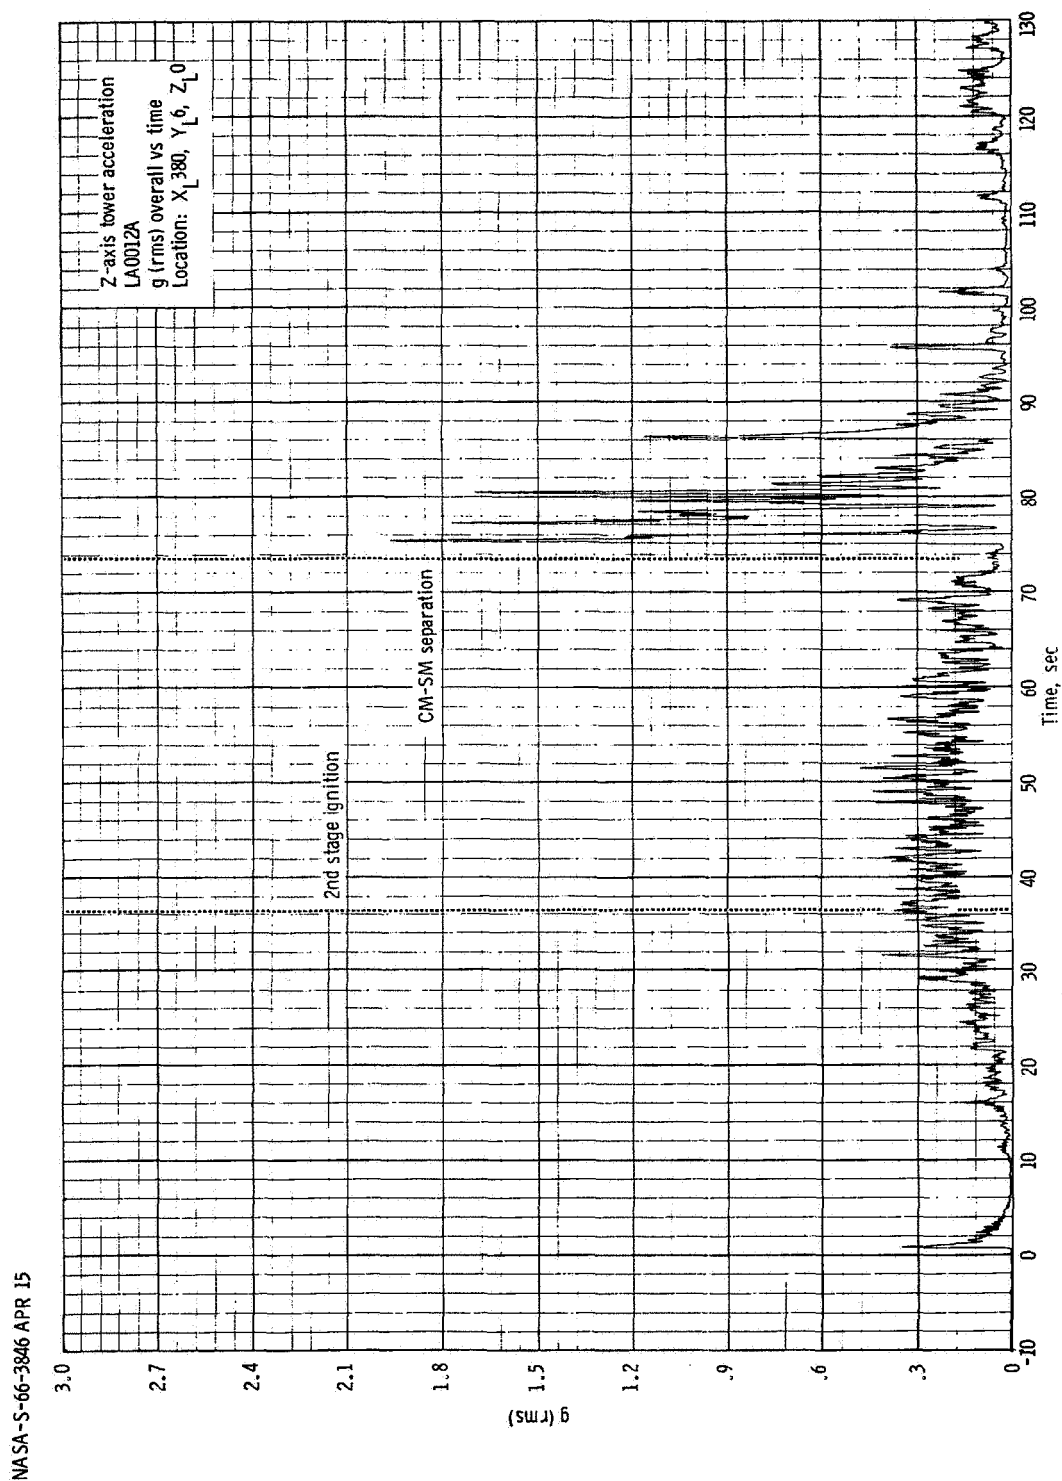
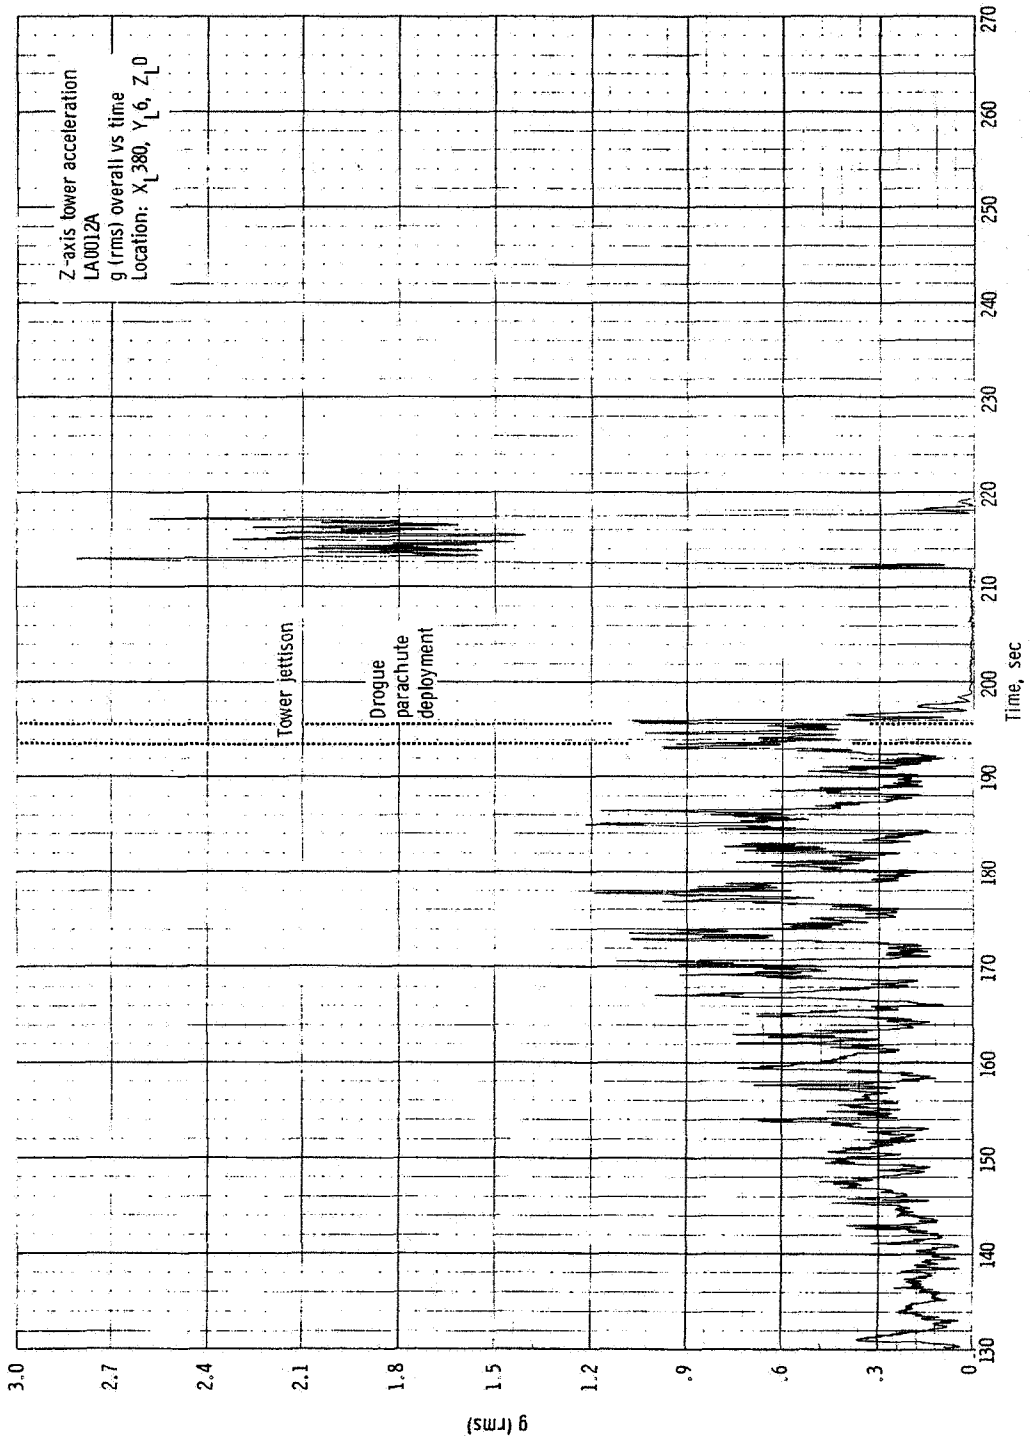
Figure 5.3-4. - rms time history of Z-axis tower acceleration, Apollo Mission A-004.

(a) -10 to 130 seconds.

(b) 130 to 270 seconds.  
Figure 5.3-4. - Concluded.

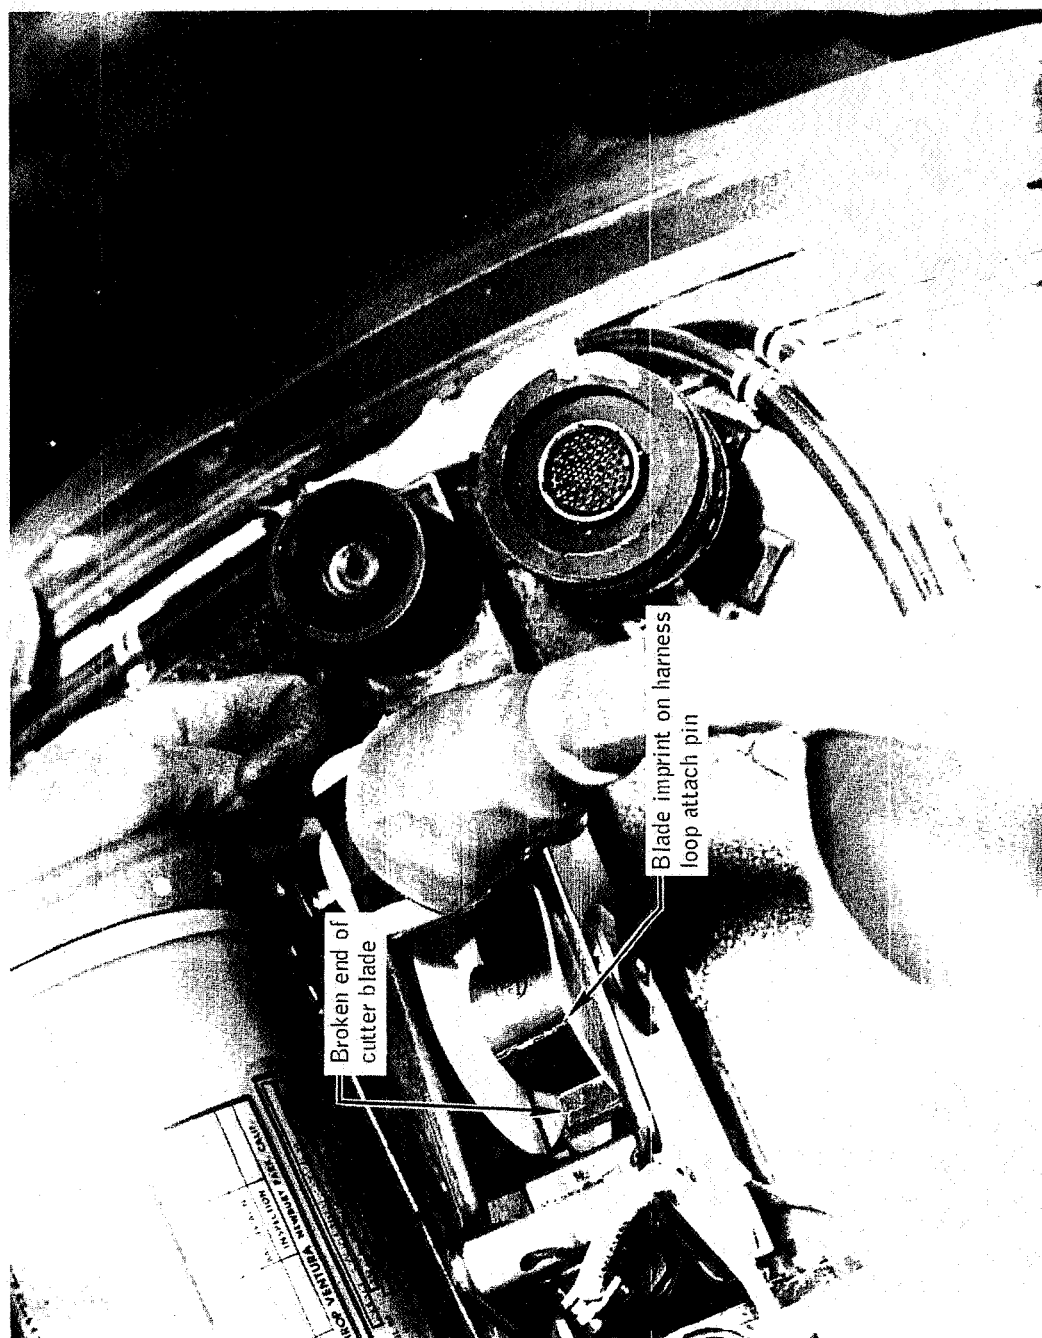
Figure 5.8-5.- No. 2 main parachute attach fitting and disconnect, Apollo Mission A-004.

Both the high-altitude and low-altitude baroswitches operated within the barometric pressure altitude ranges specified. Reefing-line cutters fired and cutter lanyards were undamaged. Both main parachute harness legs were cleanly cut (fig. 5.8-4) although the postflight inspection showed that the cutter blade on leg no. 2 was broken (fig. 5.8-5).
